**Flood Control Project Maintenance
Levee Inspections****LMA District Cover Sheet****Spring 2011 Levee Inspection Results****Reclamation District No. 0010 Honcut**

Levee Inspection Report By Mile - Spring 2011

Reclamation District No. 0010 Honcut

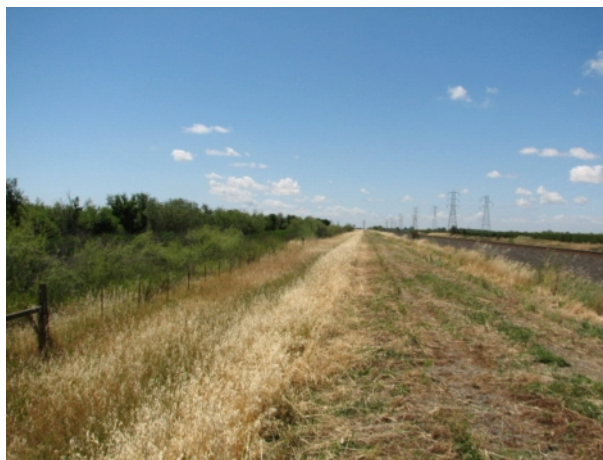
| Levee Mile Report Line | 1 |

| LMR No. | Levee Mile | | Category | Item | * Location | ** Rating | Action/Comment | GPS Latitude/Longitude | | Issue No. Photo |
|---|---|---|---|---|---|---|---|---|---|---|
| 1 | 0.00 | 7.67 | Earthen Levee | Vegetation | WS | M | Control annual grass and weeds on the levee slopes and easements. | 39.163714 ° -121.609941 ° | 39.256048 ° -121.574920 ° | 2 Y |

Levee mile 7.67, this photo shows the vegetation on the waterside slope.

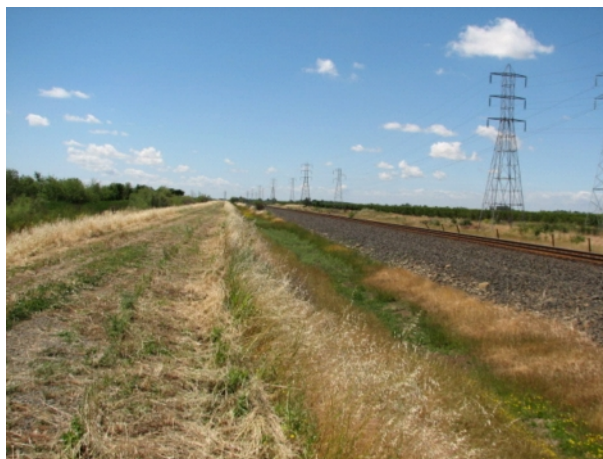
| Levee Mile Report Line | 2 |

| LMR No. | Levee Mile | | Category | Item | * Location | ** Rating | Action/Comment | GPS Latitude/Longitude | | Issue No. Photo |
|---|---|---|---|---|---|---|---|---|---|---|
| 2 | 0.00 | 7.67 | Earthen Levee | Vegetation | LS | M | Control annual grass and weeds on the levee slopes and easements. | 39.163714 ° -121.609941 ° | 39.256048 ° -121.574920 ° | 3 Y |

Levee mile 7.67, this photo shows the vegetation on the landside slope.

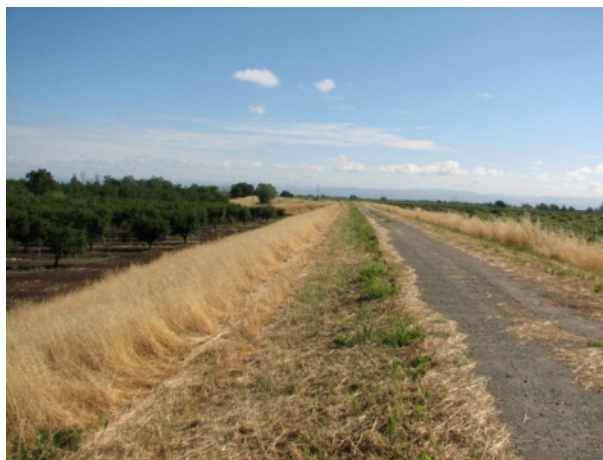
| Levee Mile Report Line | 1 |

| LMR No. | Levee Mile | | Category | Item | Location | Rating | Action/Comment | GPS Latitude/Longitude | | Issue No. Photo |
|---|---|---|---|---|---|---|--|---|---|---|
| 1 | 0.00 | 11.19 | Earthen Levee | Vegetation | WS | M | Control annual grass and weeds on the levee slopes and easements. | 39.163714 ° -121.609940 ° | 39.307024 ° -121.617313 ° | 2 Y |

Levee mile 6.70, this photo is looking at the vegetation on the waterside slope.

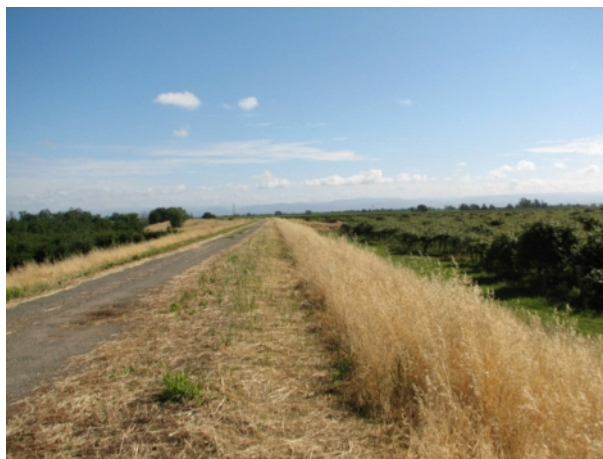
| Levee Mile Report Line | 2 |

| LMR No. | Levee Mile | | Category | Item | Location | Rating | Action/Comment | GPS Latitude/Longitude | | Issue No. Photo |
|---|---|---|---|---|---|---|--|---|---|---|
| 2 | 0.00 | 11.19 | Earthen Levee | Vegetation | LS | M | Control annual grass and weeds on the levee slopes and easements. | 39.163714 ° -121.609940 ° | 39.307024 ° -121.617311 ° | 1 Y |

Levee mile 6.70, this photo is looking at the vegetation on the landside slope.

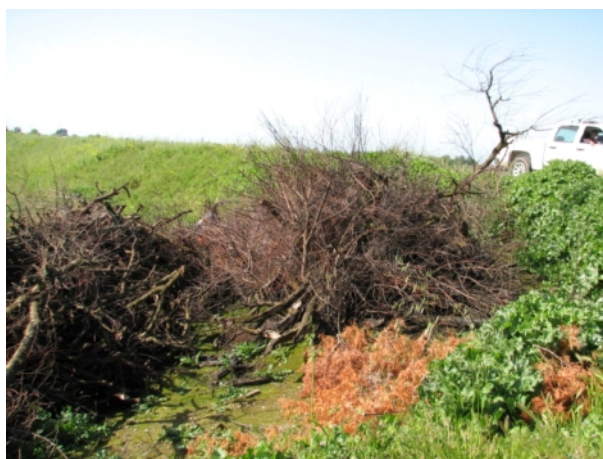
| Levee Mile Report Line | 7 |

| LMR No. | Levee Mile | | Category | Item | Location | Rating | Action/Comment | GPS Latitude/Longitude | | Issue No. Photo |
|---|---|---|---|---|---|---|--|---|---|---|
| 7 | 9.30 | 9.30 | Earthen Levee | Encroachments | LS | M | Prunings | 39.285883 ° -121.600353 ° | 39.285883 ° -121.600353 ° | 3 Y |

Land side levee mile 9.30.

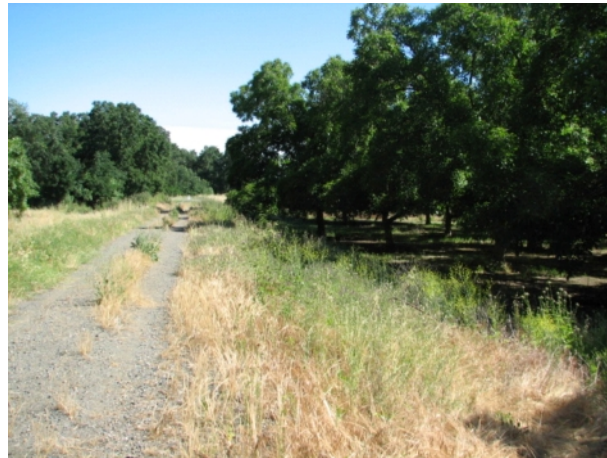
| Levee Mile Report Line | 1 |

| LMIR No. | Levee Mile | | Category | Item | * Location | ** Rating | Action/Comment | GPS Latitude/Longitude | | Issue No. |
|---|---|---|---|---|---|---|---|---|---|---|
| 1 | 0.00 | 2.89 | Earthen Levee | Vegetation | LS | M | Control annual grass and weeds on the levee slopes and easements. | 39.307868 ° -121.617070 ° | 39.299152 ° -121.571802 ° | 3 Y |

Levee mile 0.02, this photo is looking at the vegetation on the landside slope.

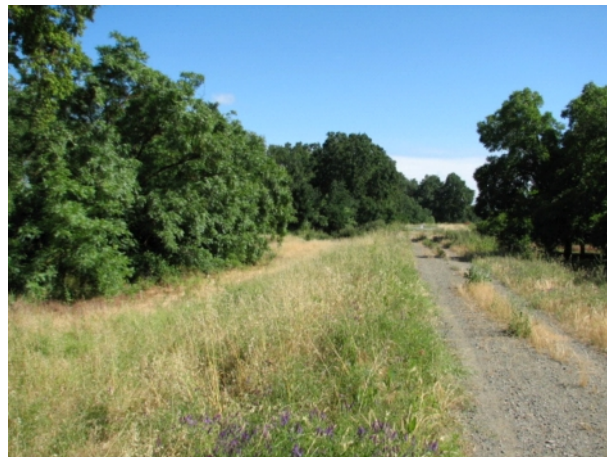
| Levee Mile Report Line | 2 |

| LMIR No. | Levee Mile | | Category | Item | * Location | ** Rating | Action/Comment | GPS Latitude/Longitude | | Issue No. |
|---|---|---|---|---|---|---|---|---|---|---|
| 2 | 0.00 | 2.89 | Earthen Levee | Vegetation | WS | M | Control annual grass and weeds on the levee slopes and easements. | 39.307869 ° -121.617070 ° | 39.299152 ° -121.571801 ° | 1 Y |

Levee mile 0.02, this photo is looking at the vegetation on the waterside slope.
